Diagnostic Measurements on Instrument Transformers

Examples and Case Studies

Dr. Michael Krüger, OMICRON

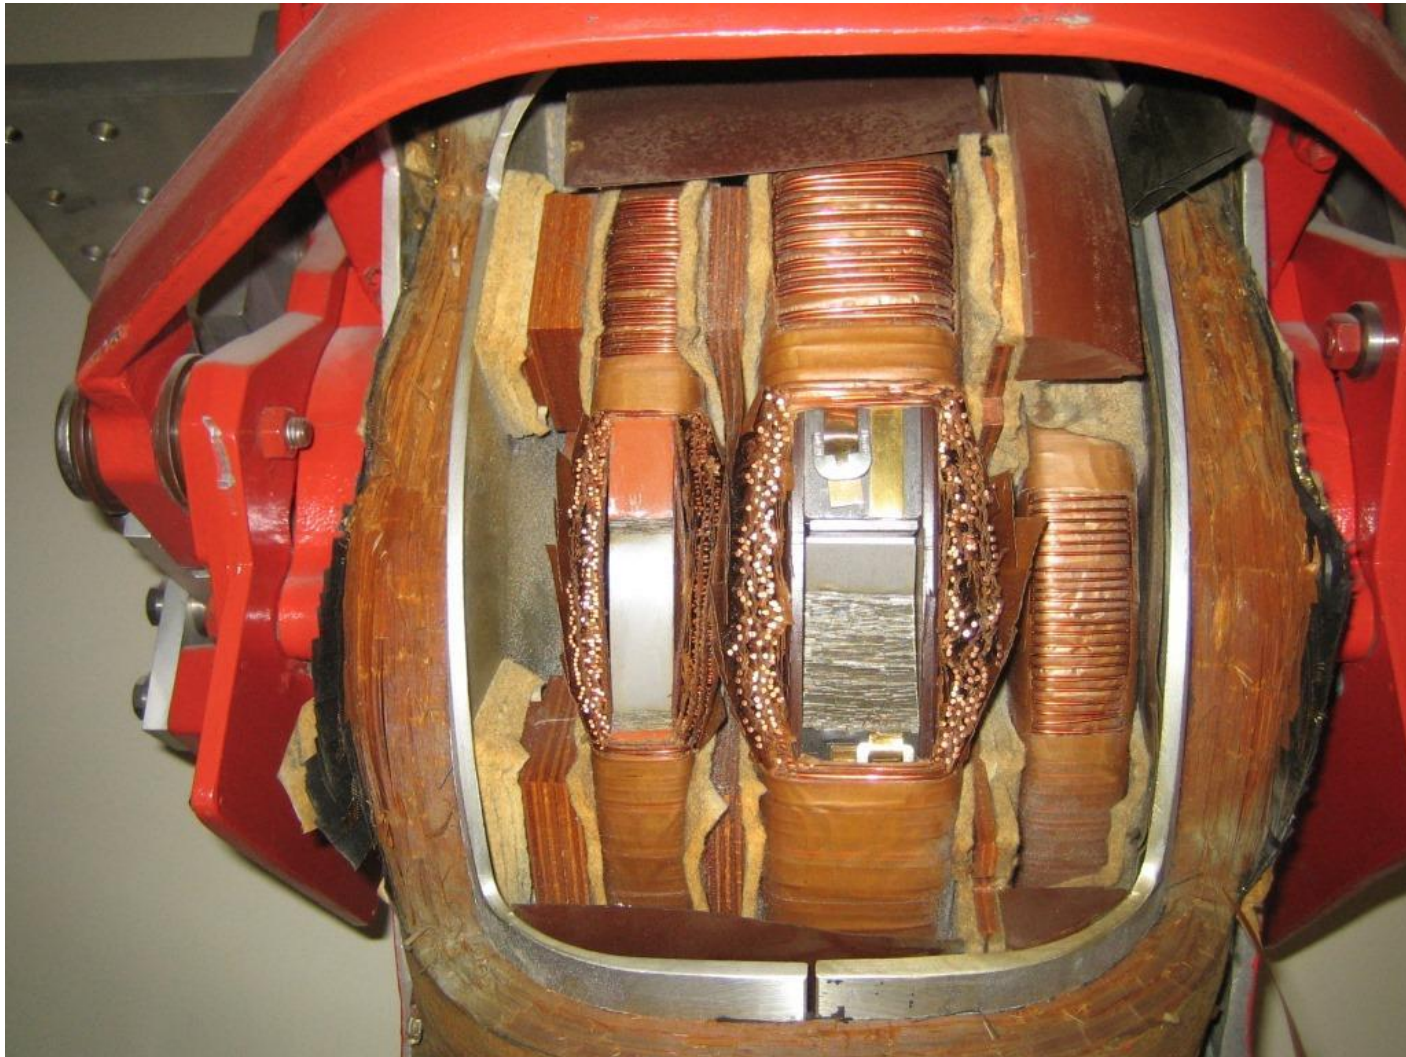
Insulation in a Current Transformer

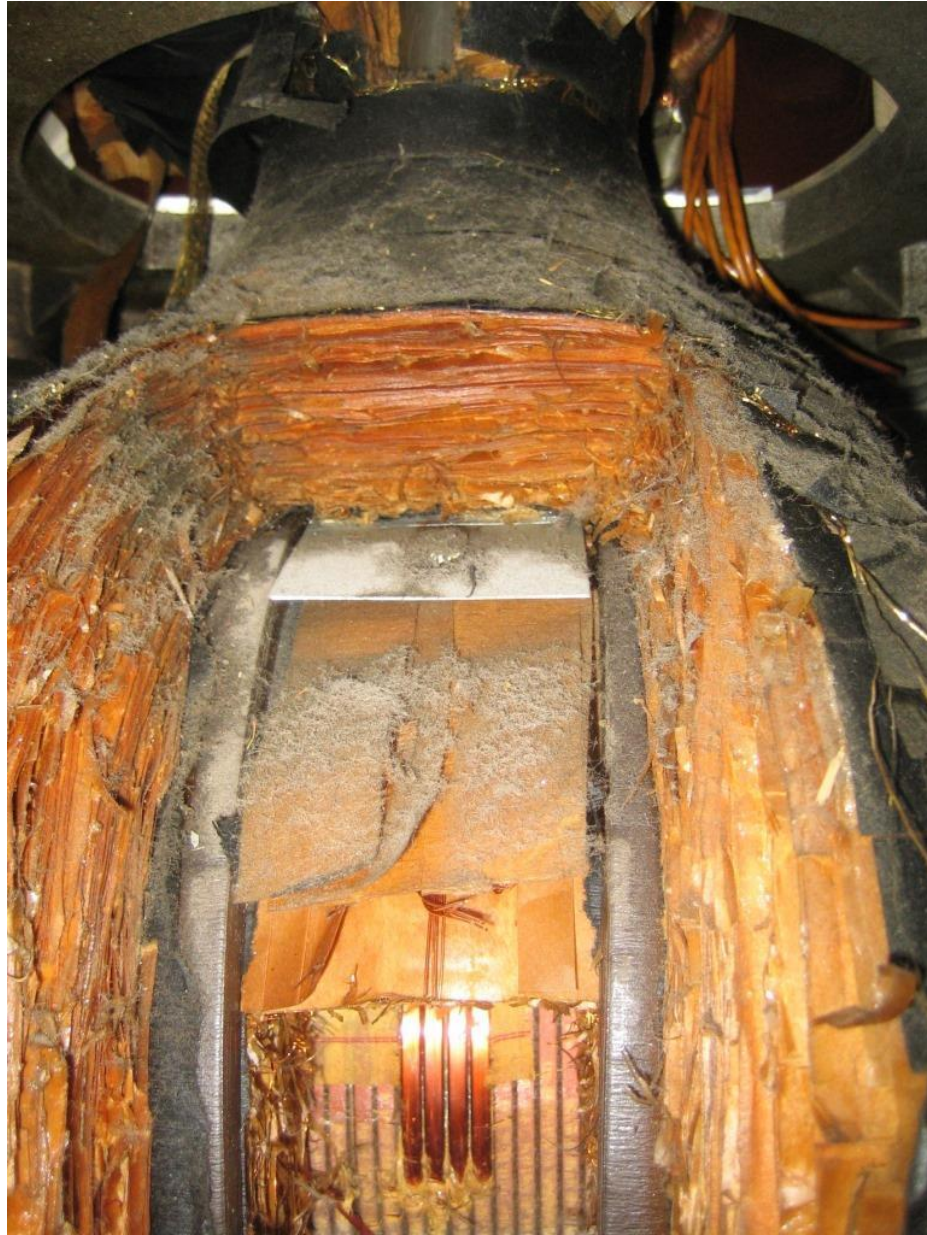
Insulation in a Voltage Transformer

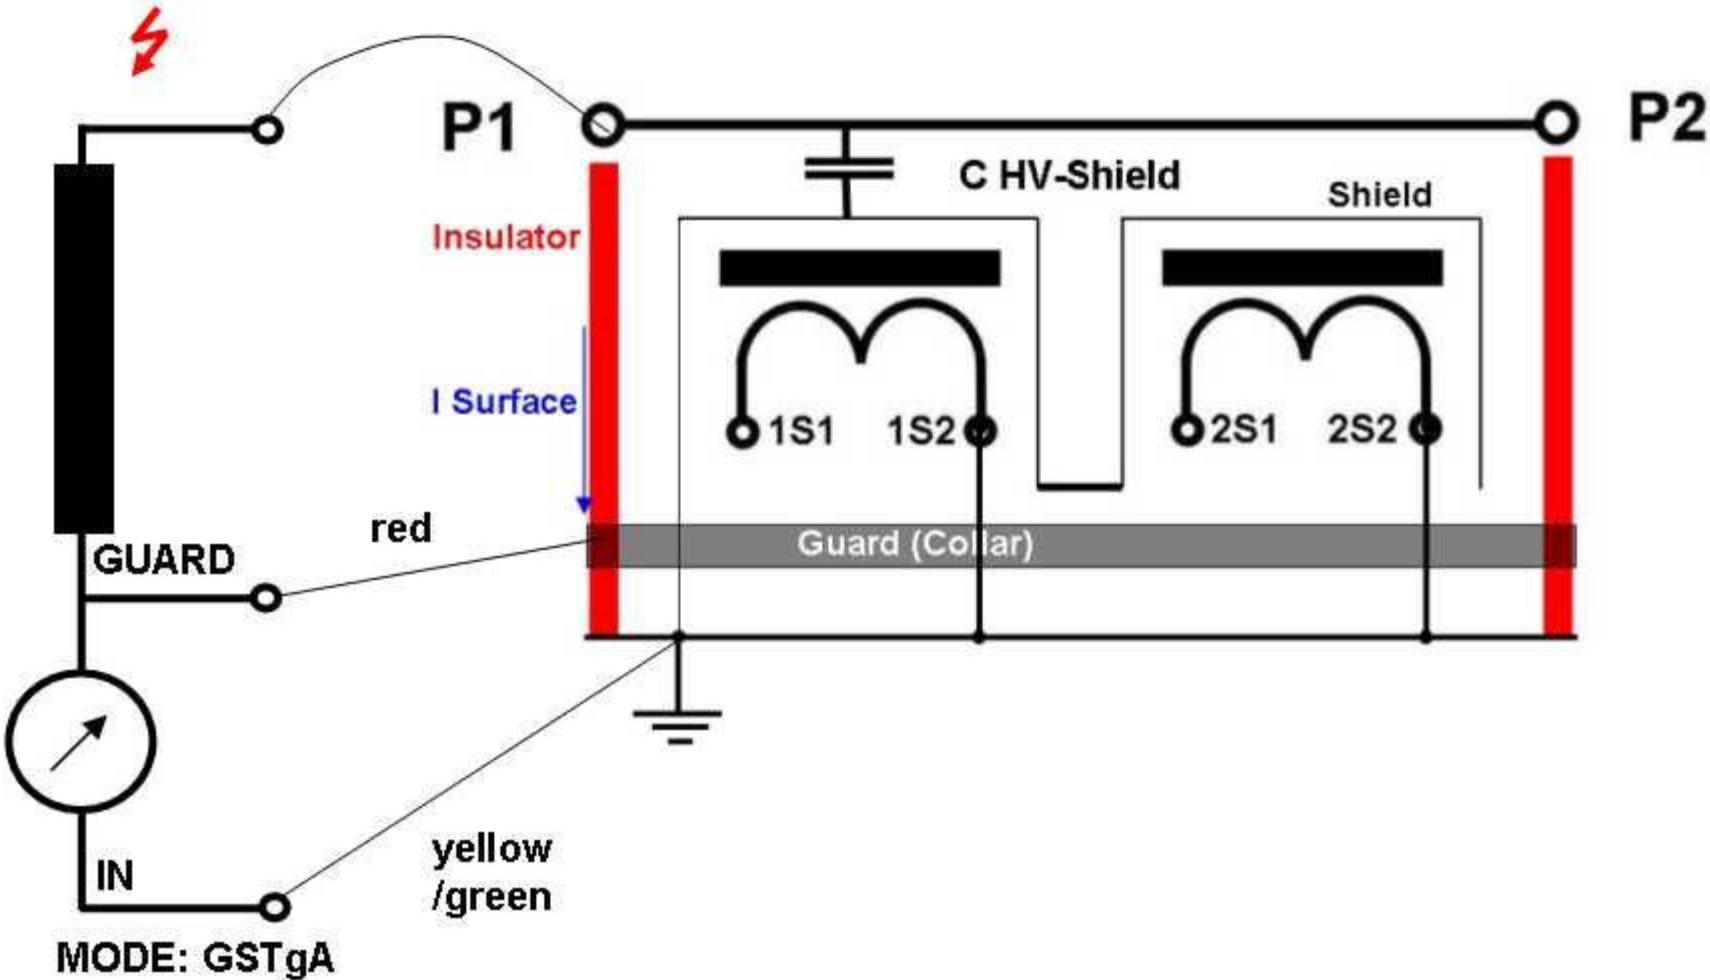
Measurement Current Transformer

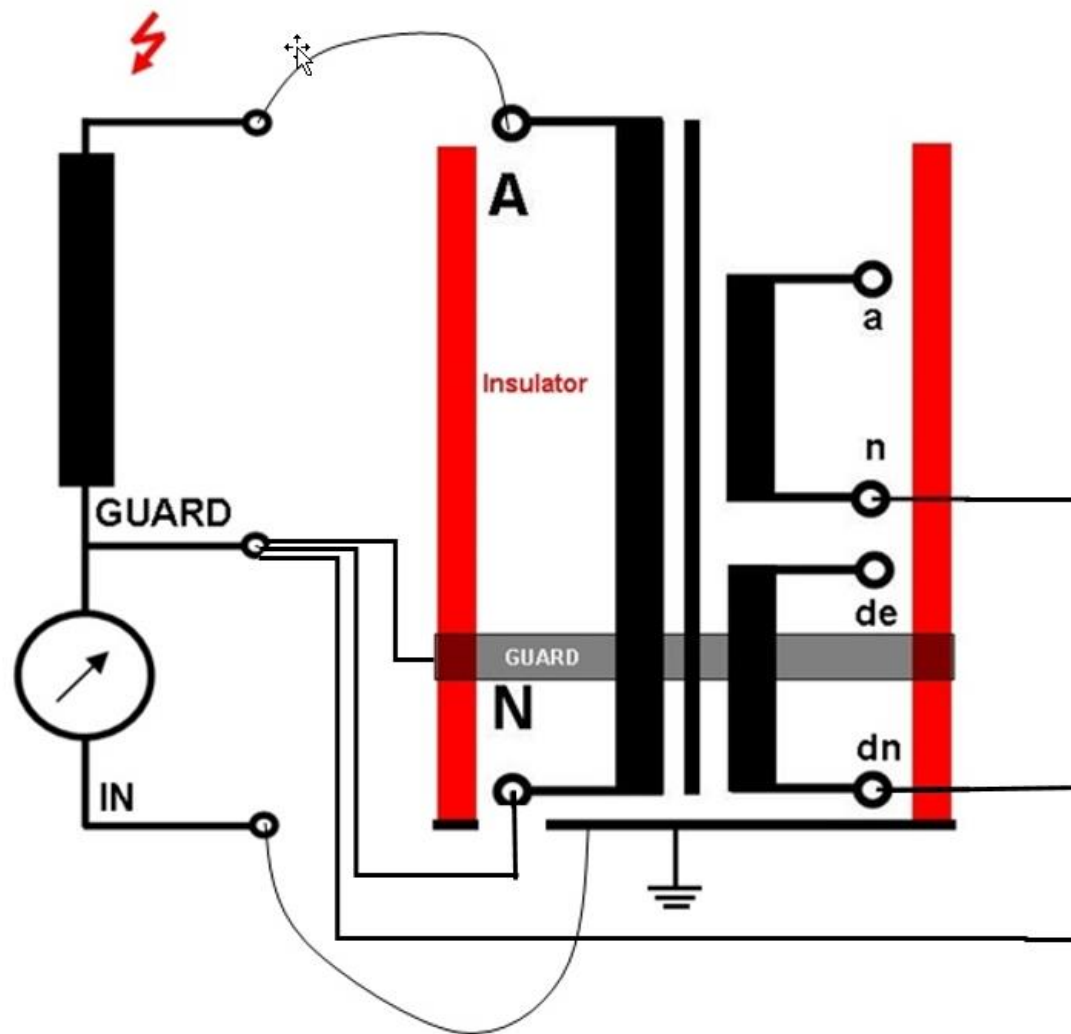
Measurement Voltage Transformers

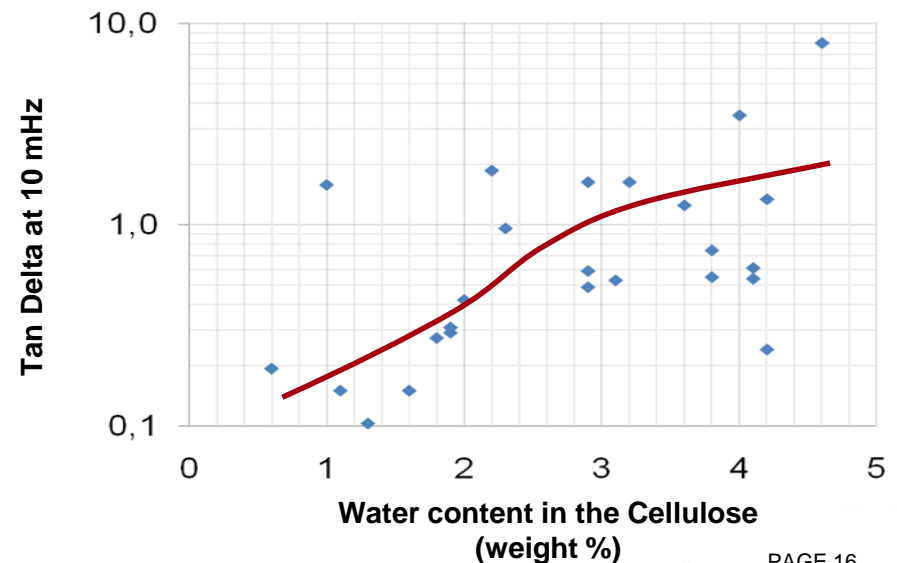
Tan Delta at 10 mHz

- $\tan(\delta)$ at 10 mHz is strongly dependent on ageing and moisture
 - $\tan(\delta)$ is dependent on the temperature
- $\tan(\delta)$ at 10 mHz is a good tool for the insulation assessment

Dependency on the temperature

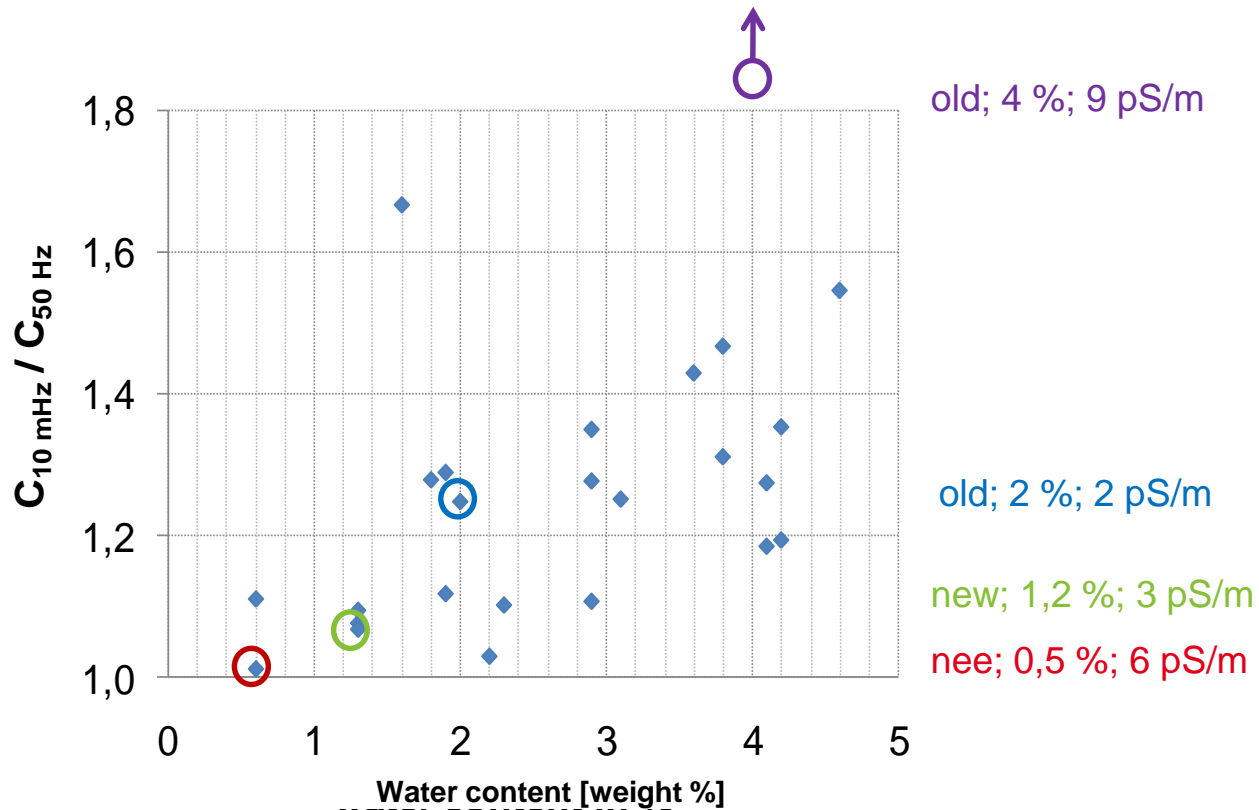
Capacitance over Frequency

- Capacitance is constant for dry IT's, for wet IT's not
- $C_{10\text{mHz}}/C_{50\text{Hz}}$ is independent on the temperature

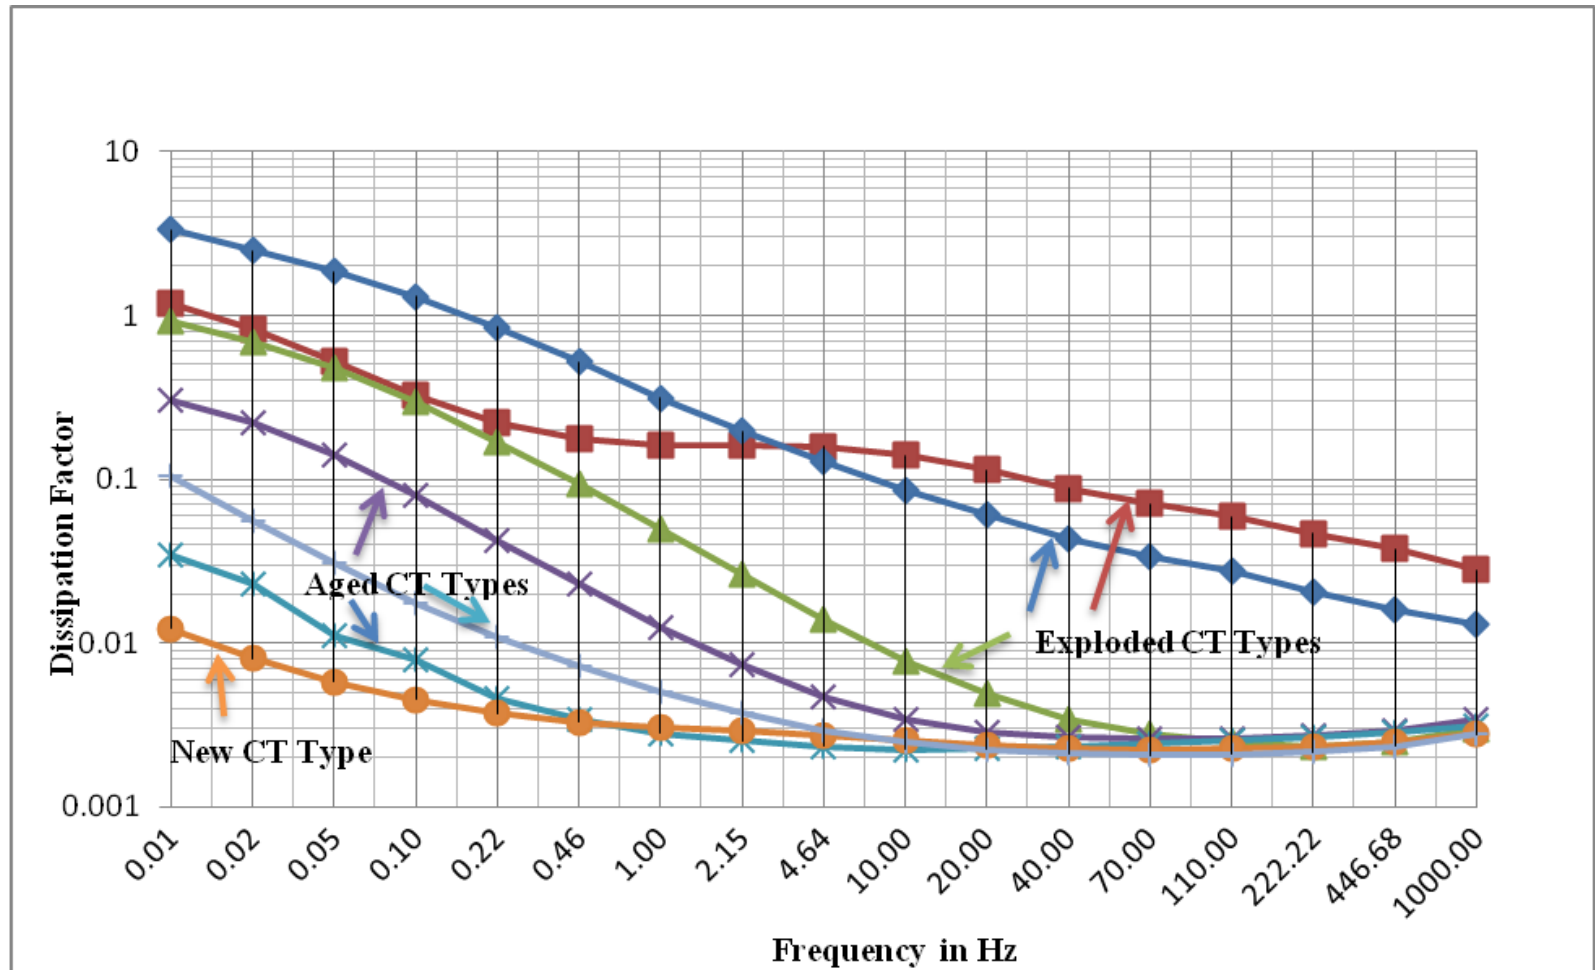
Tan Delta Curves of different CTs

CT Group	Average Ratio of Capacitance at 10mHz to Capacitance at 50Hz
New CTs	1.02
New CTs	1.05
Aged CTs	1.05
Sister CTs of failed CT type	2.28

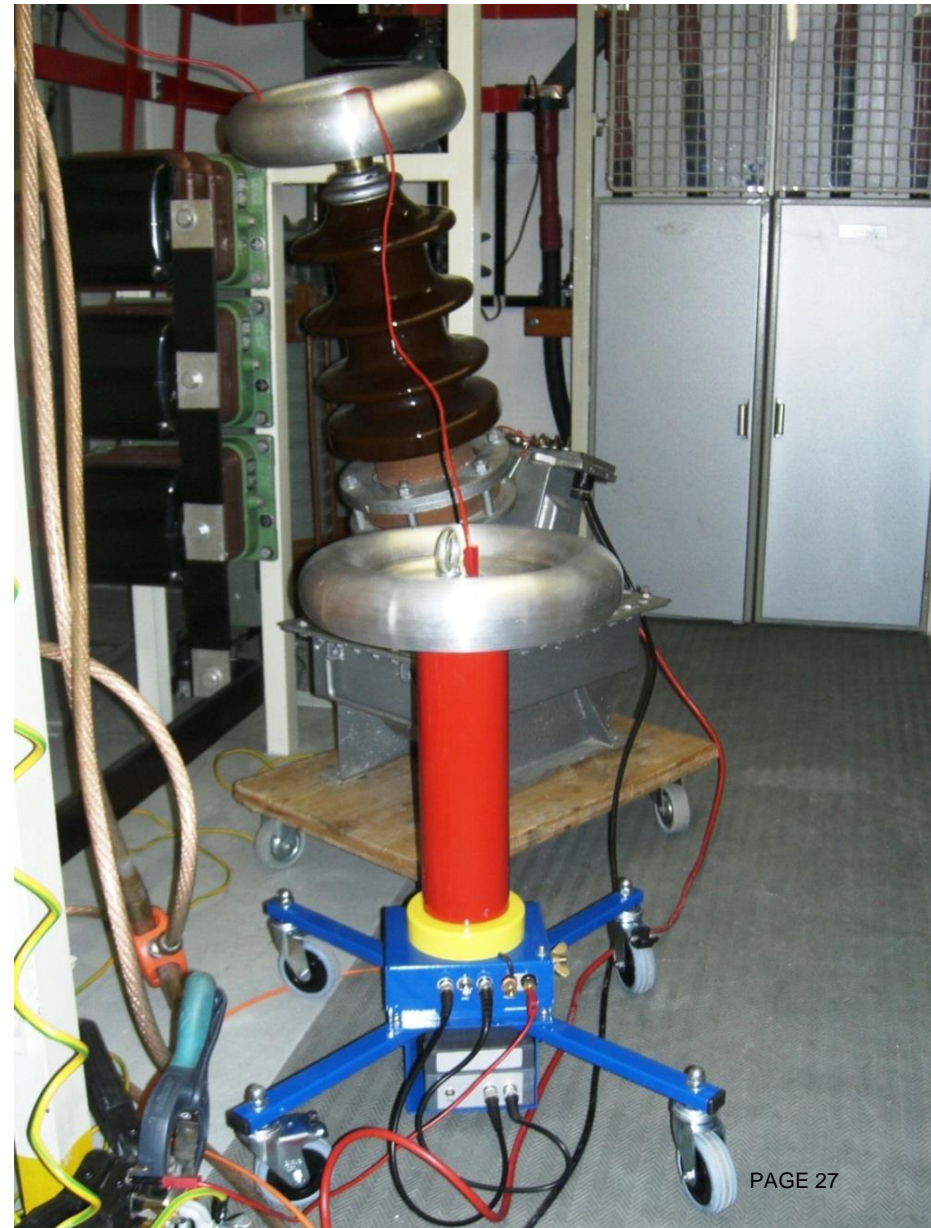
HV Transformer with Coupling Capacitor, Quadripole and PD Instrument

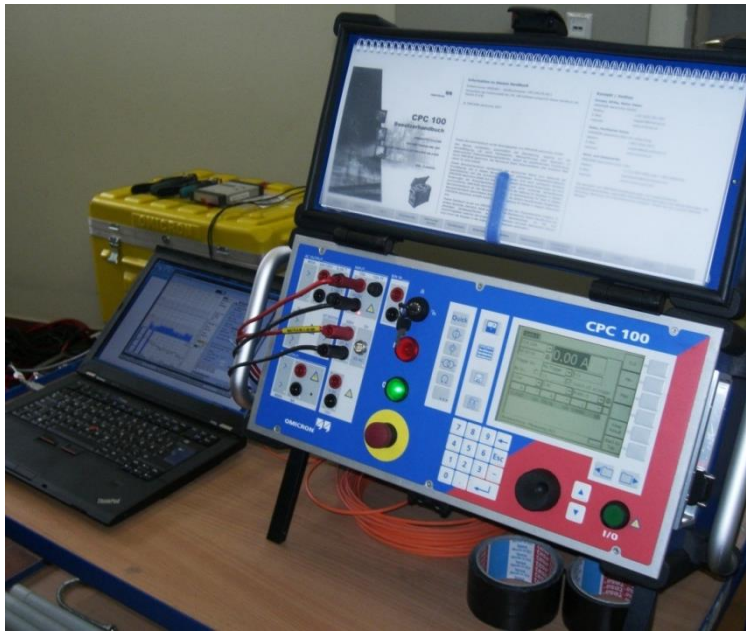
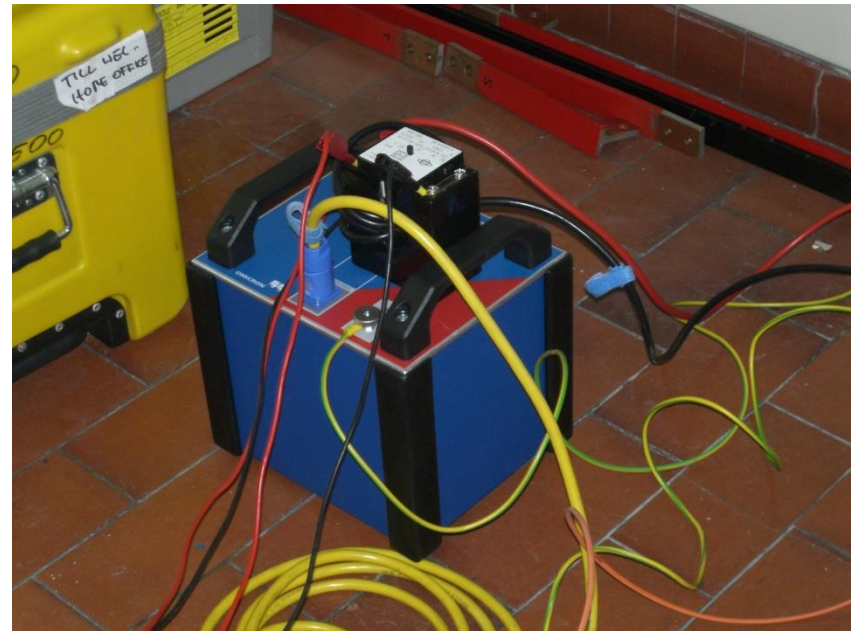
Generation of the 150Hz Test Voltage with CPC100 + TR7

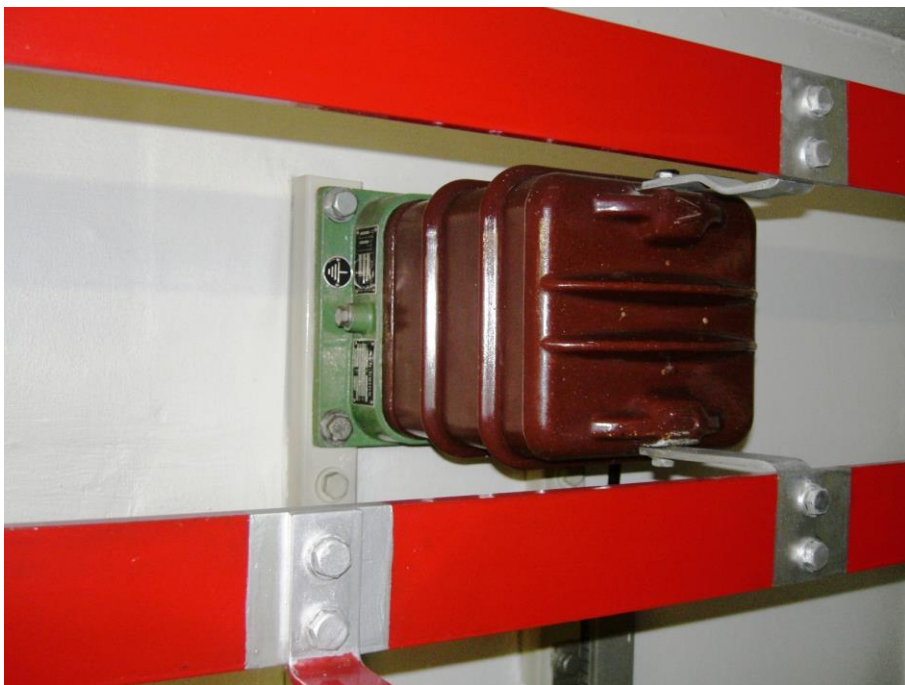
PD Measurement on 10kV Instrument Transformers

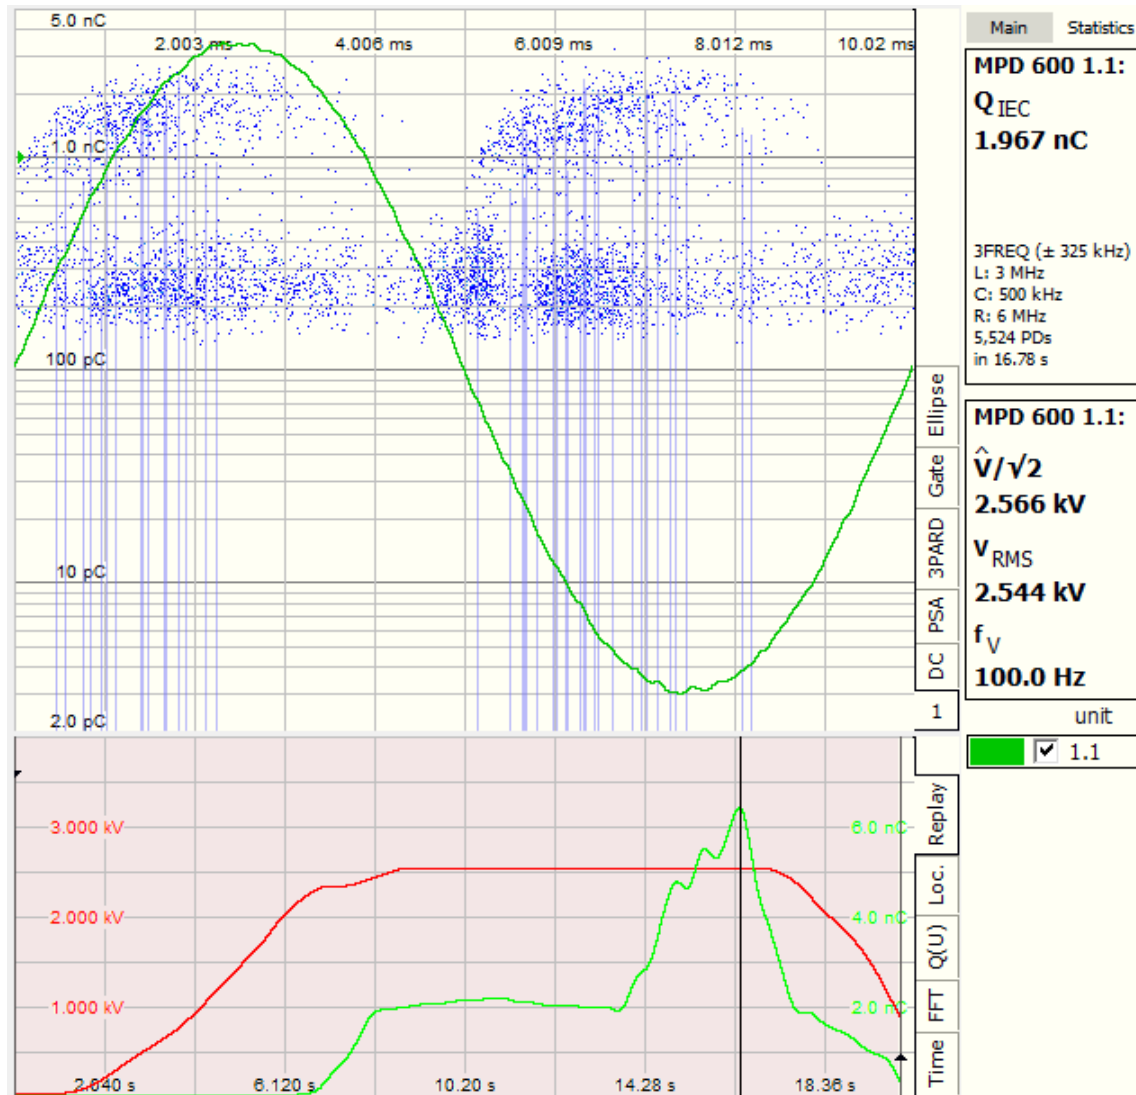
PD on a Voltage Transformer

TE = 2nC at 2.5kV!

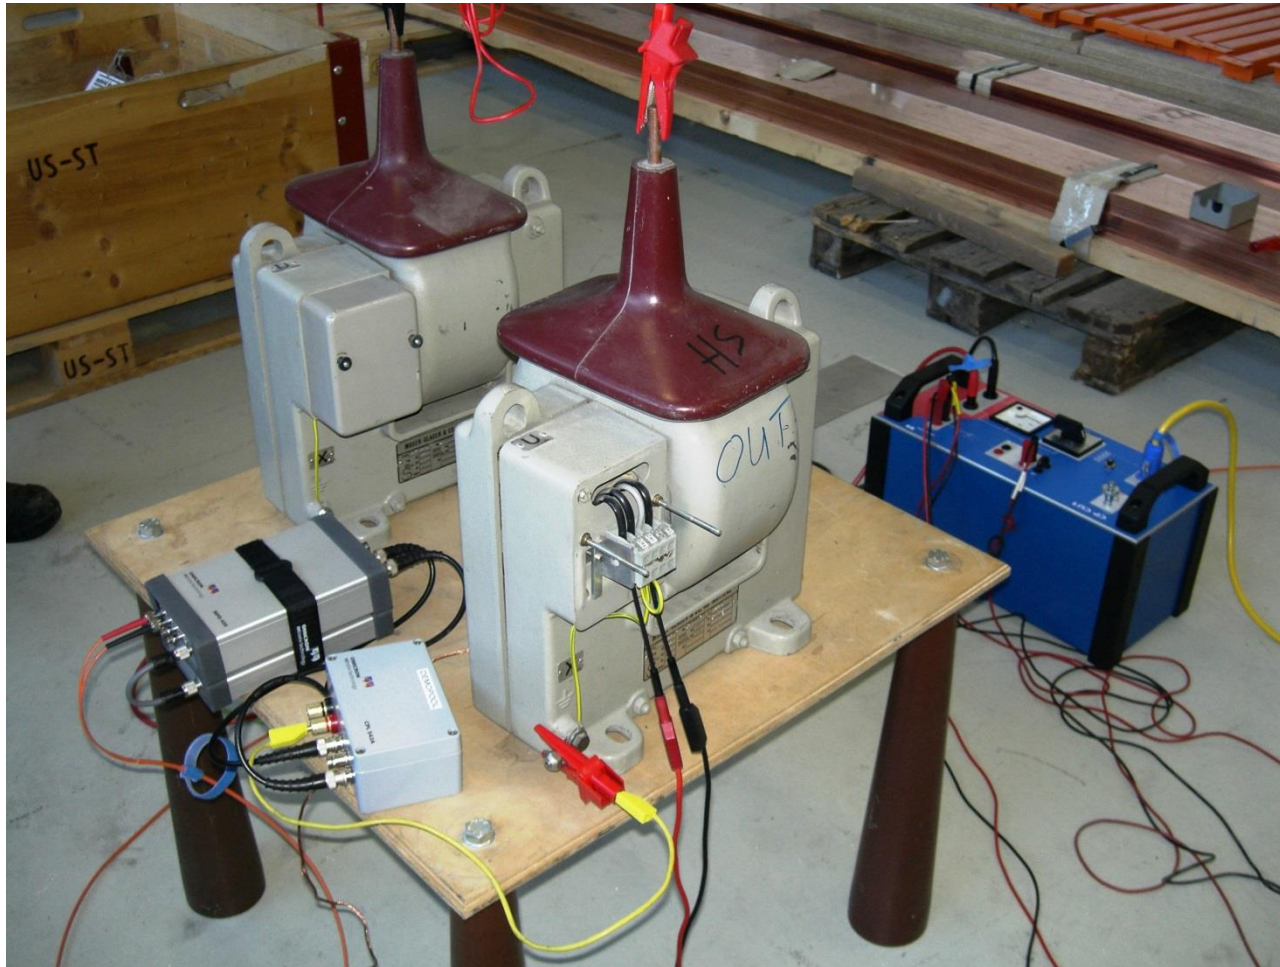
PD Measurement on 24kV Voltage Transformers (\approx 30 years old)

24kV Voltage Transformers				Limits acc. to IEC 60689		
VT's	pC			Test Voltage	kV	pC
	30kV	24kV	16kV			
1	130	<1	<1	Um = 24kV	24kV	50
2	240	150	60	1,2 x Um/Sqrt(3)	16kV	20
3	600	330	42			
4	126	<1	<1			
5	242	236	78			
6	<1	<1	<1			
7	181	164	51

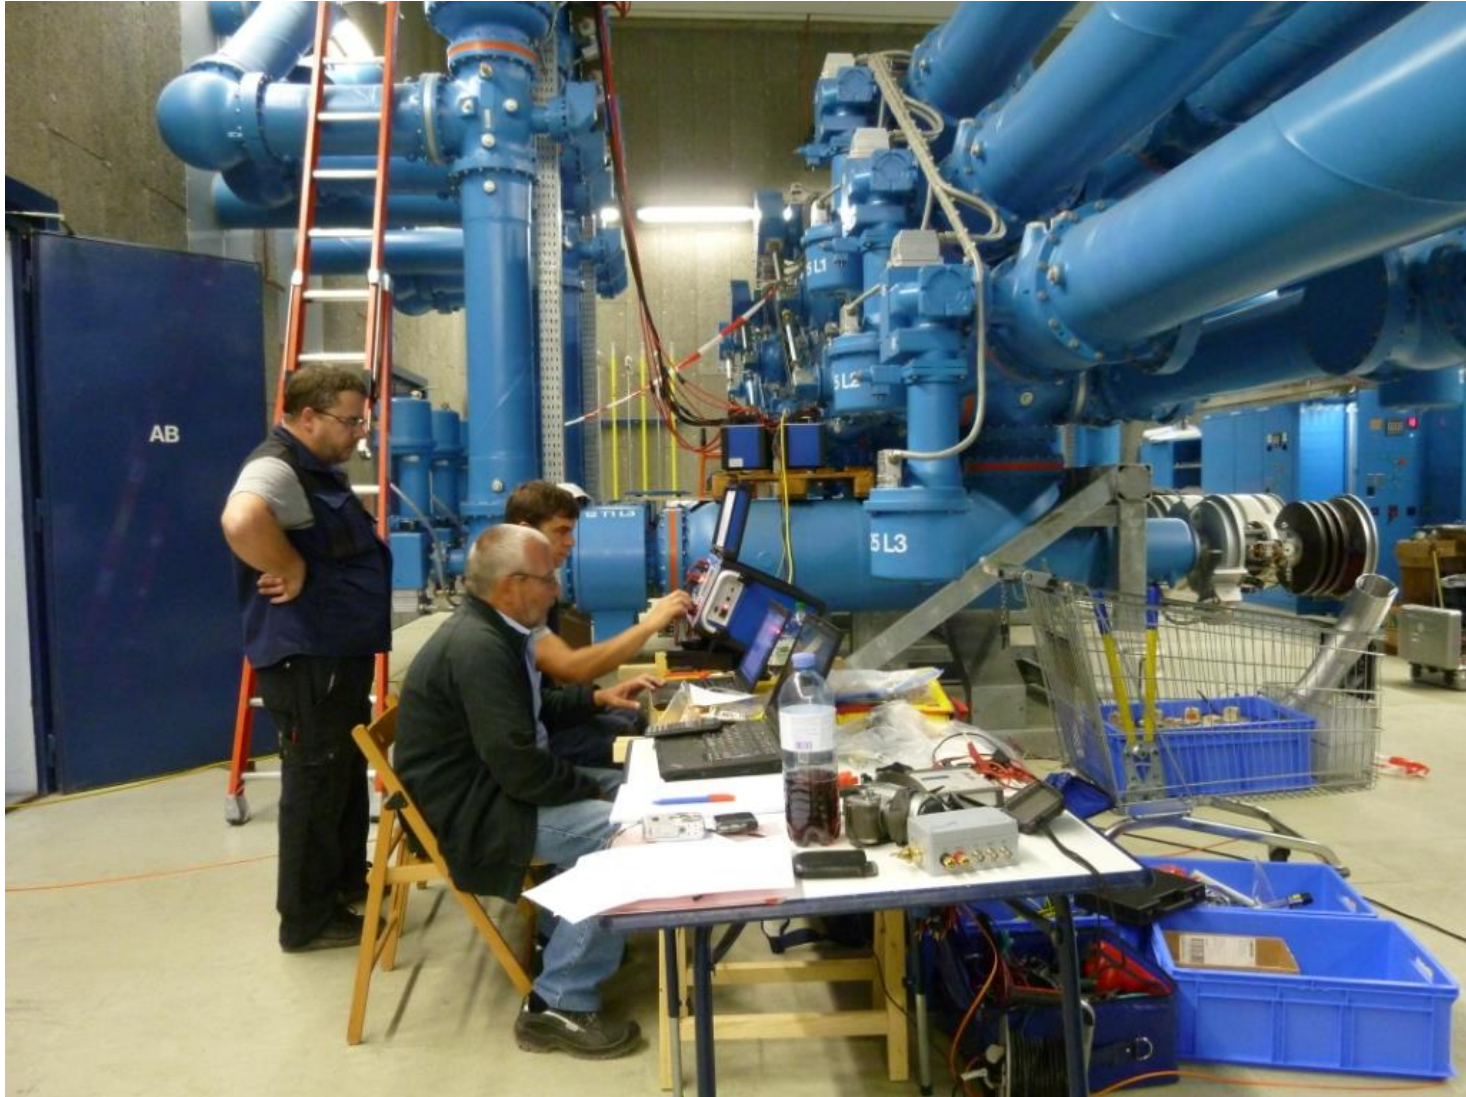
PD Measurements on GIS Voltage Transformers

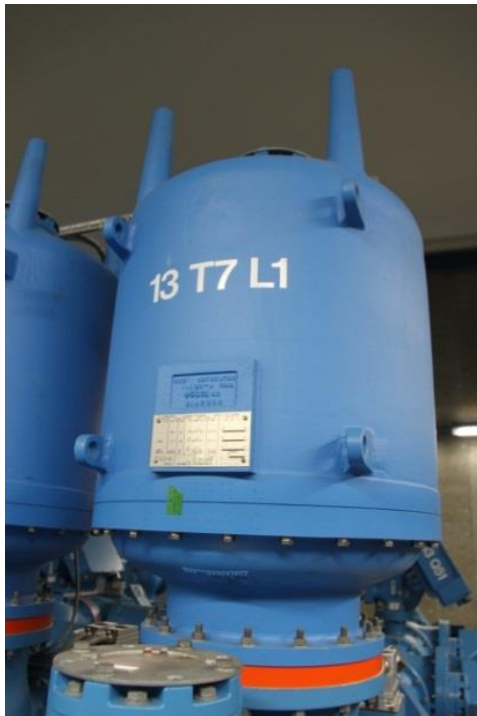
Technical Assessment

Test Voltage: $1.2 \times U_m / \sqrt{3} = 1.2 \times 242 / \sqrt{3} = 170 \text{ kV}$

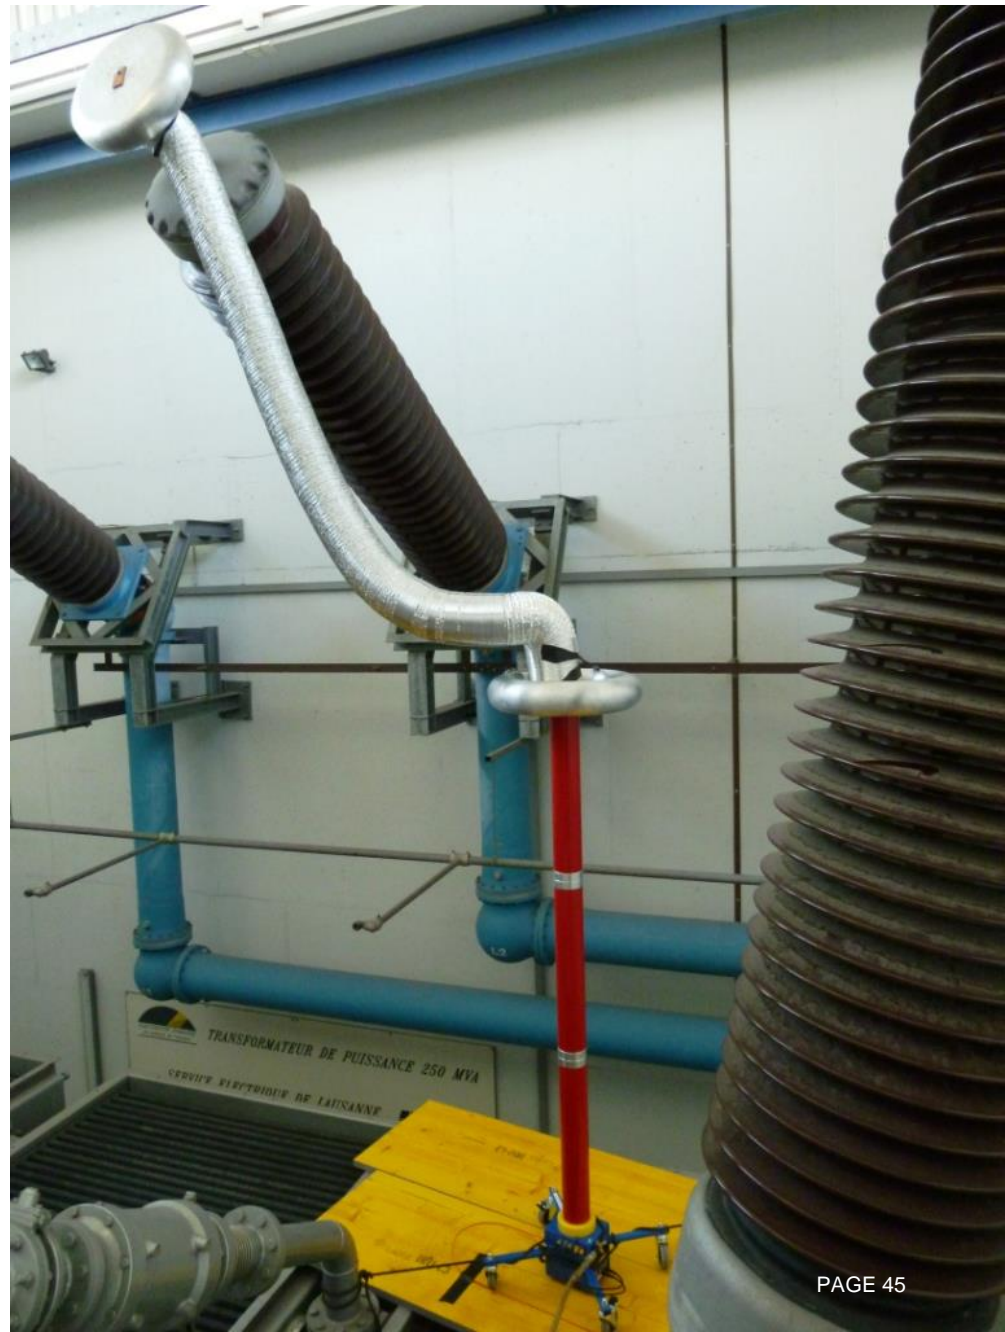
Coupling Capacitor
333pF 300kV
with Quadripole
and MDD600

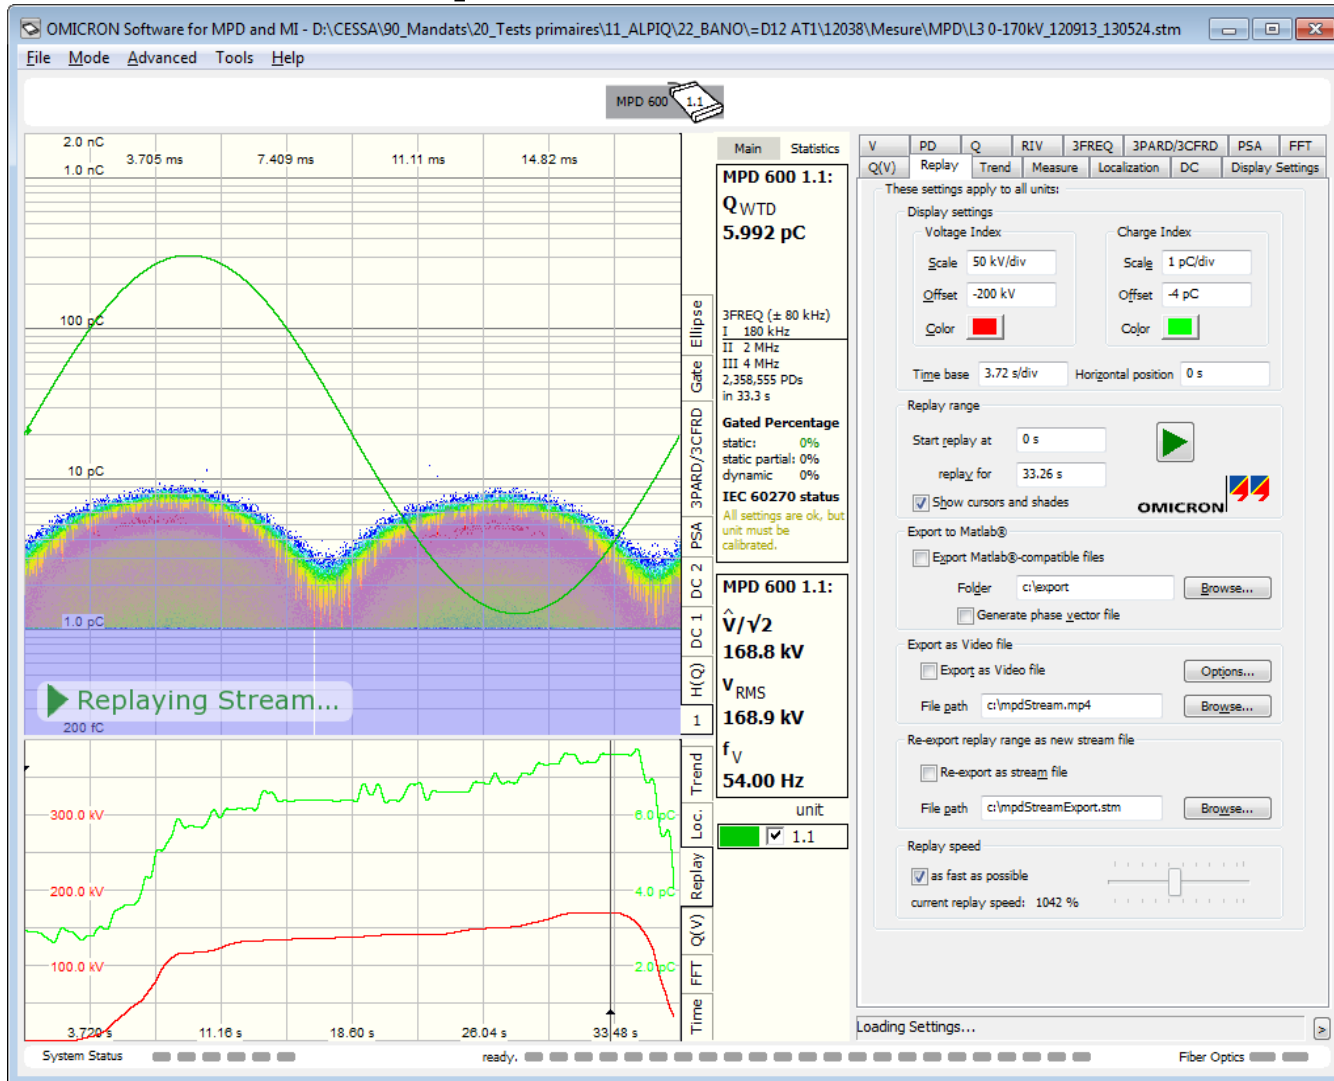
PD Level < 6pC at 170kV
